A Landslide Risk Management Approach for the  
Stillwater to Ngakawau Rail Corridor (SNL96 to 126km)  
in the Lower Buller Gorge, New Zealand

A thesis submitted in partial fulfilment of  
the requirements for the degree of

Master of Science in Hazard and Disaster Management

**UNIVERSITY OF CANTERBURY**  
**2012**

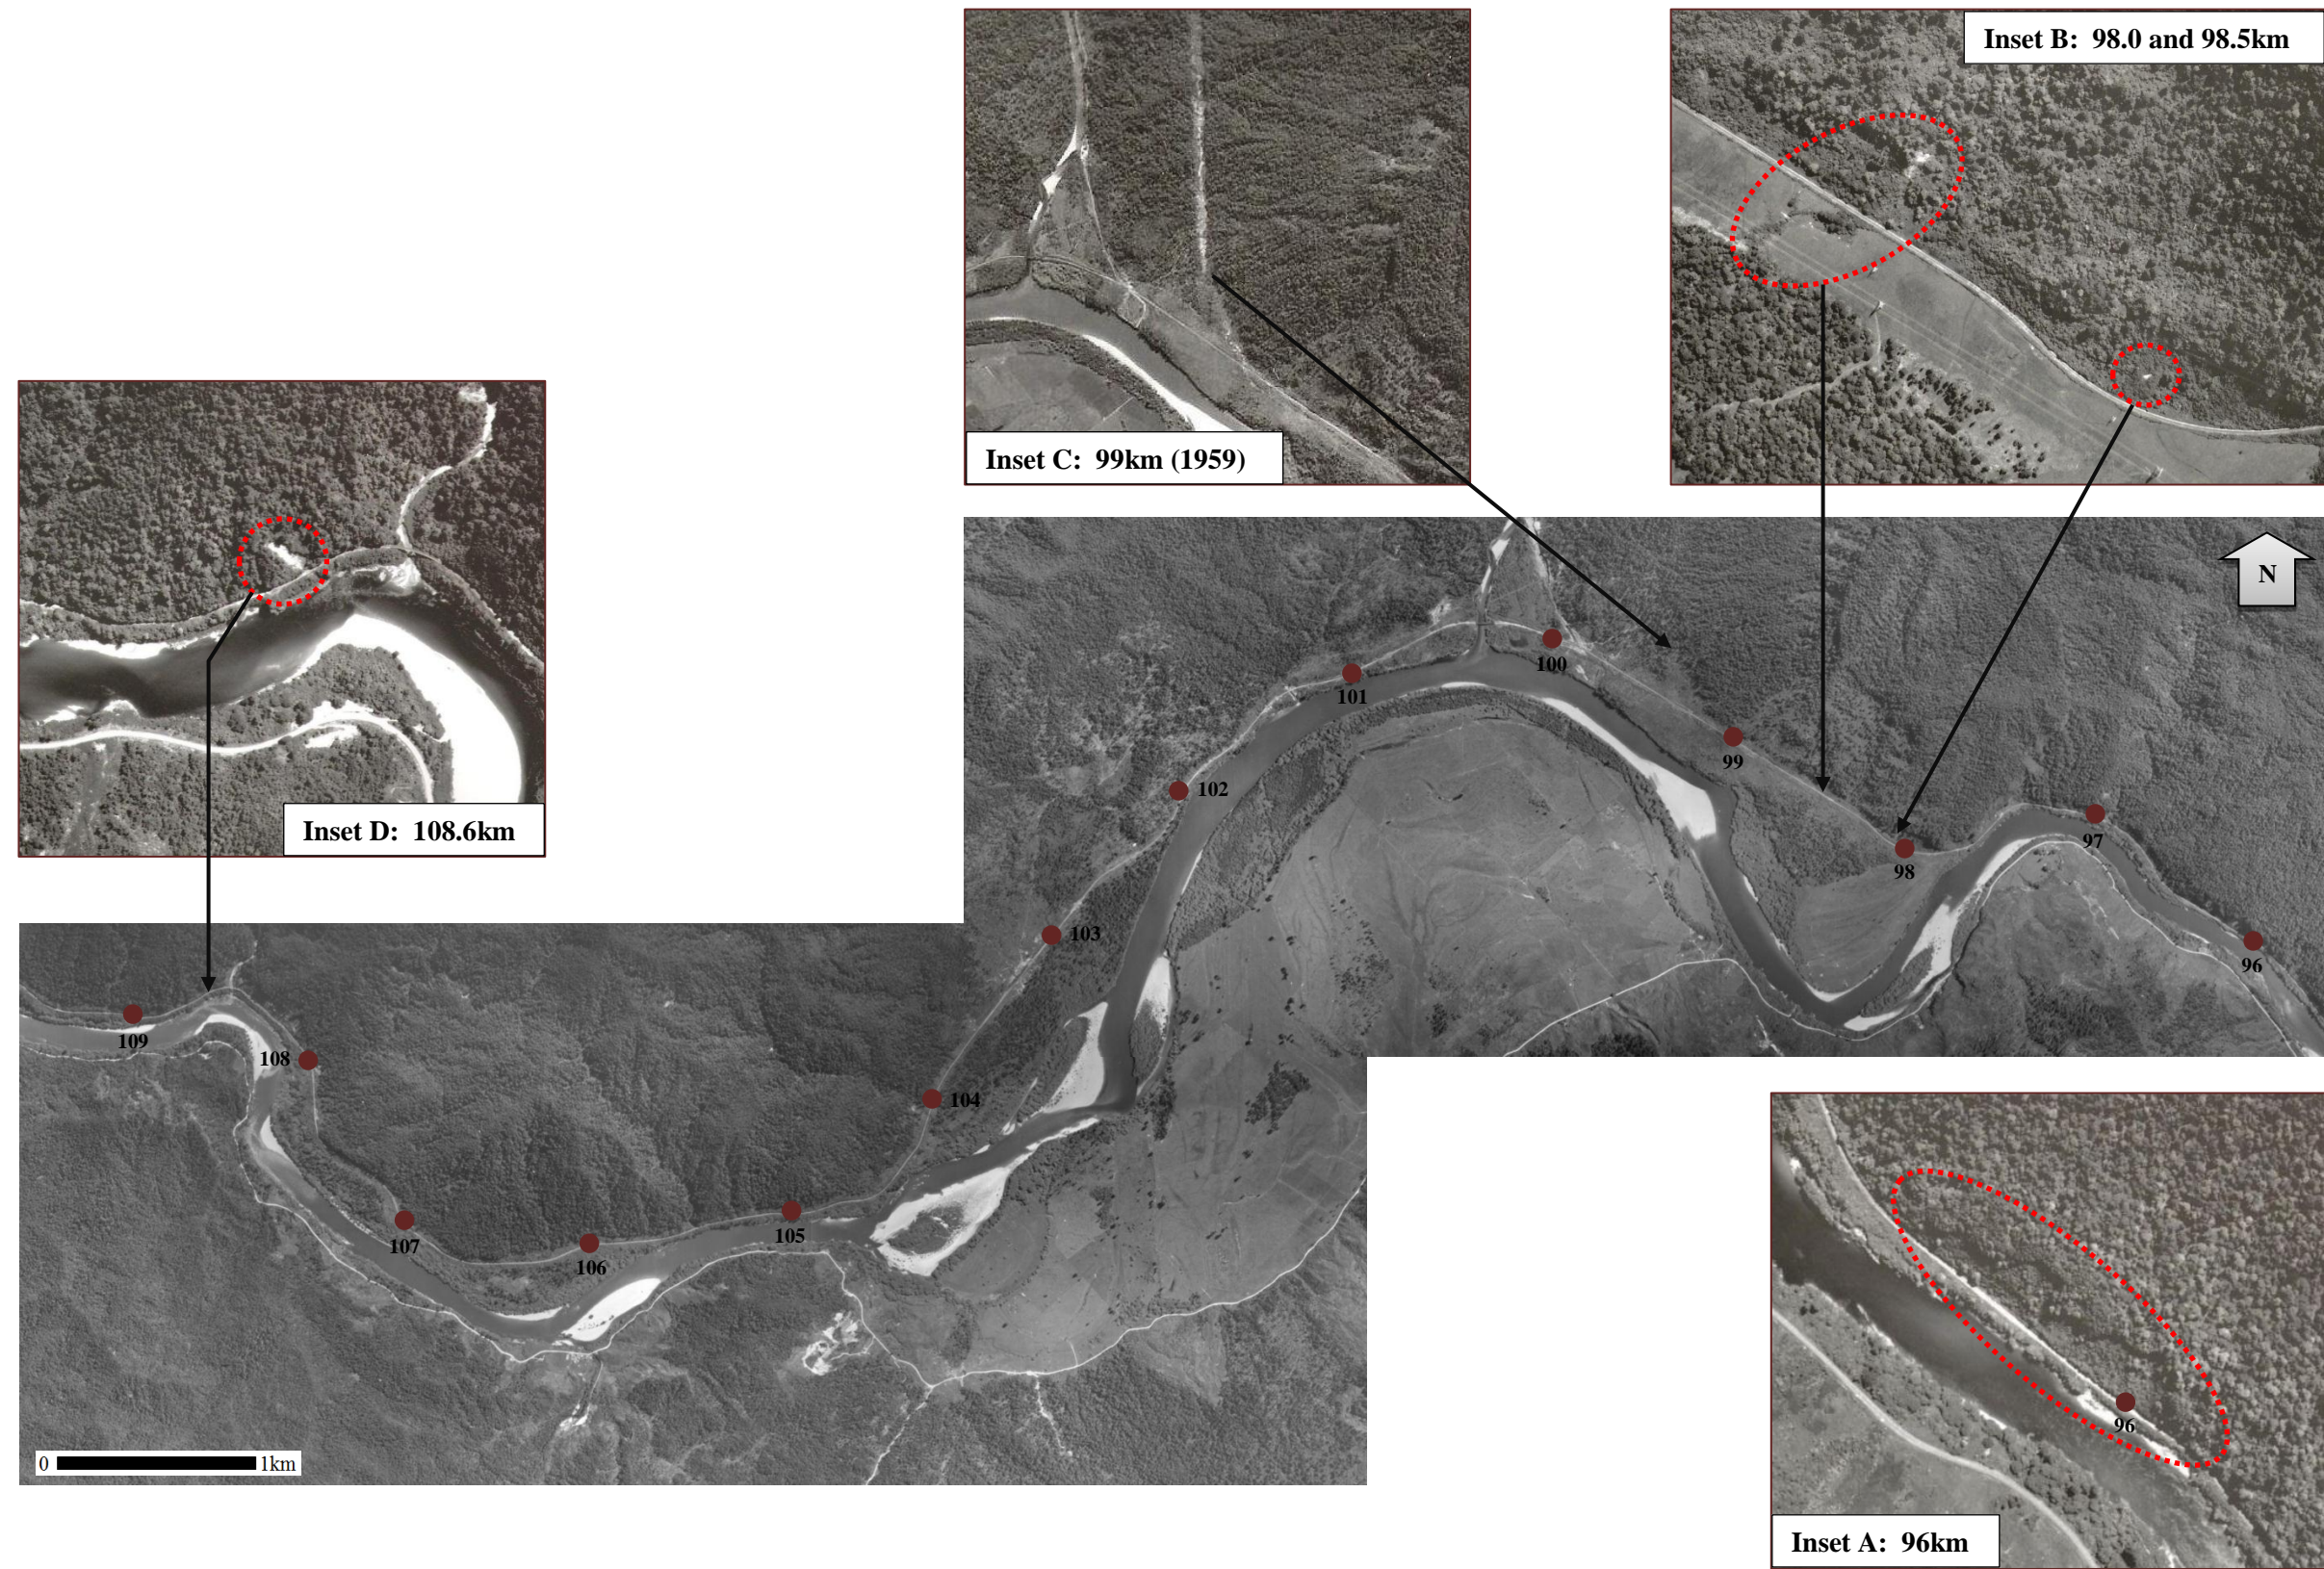
Figure A3.2.1: 1947 aerial photography between SNL96km and 109km. Refer Table A3.2.2 for inset descriptions.

97.5	No large-scale failure at Whitecliffs evident between 1947 and present day. A detailed discussion of Whitecliffs and relevant photographs is presented in Chapter 6.	No inset (Figure A3.2.1)

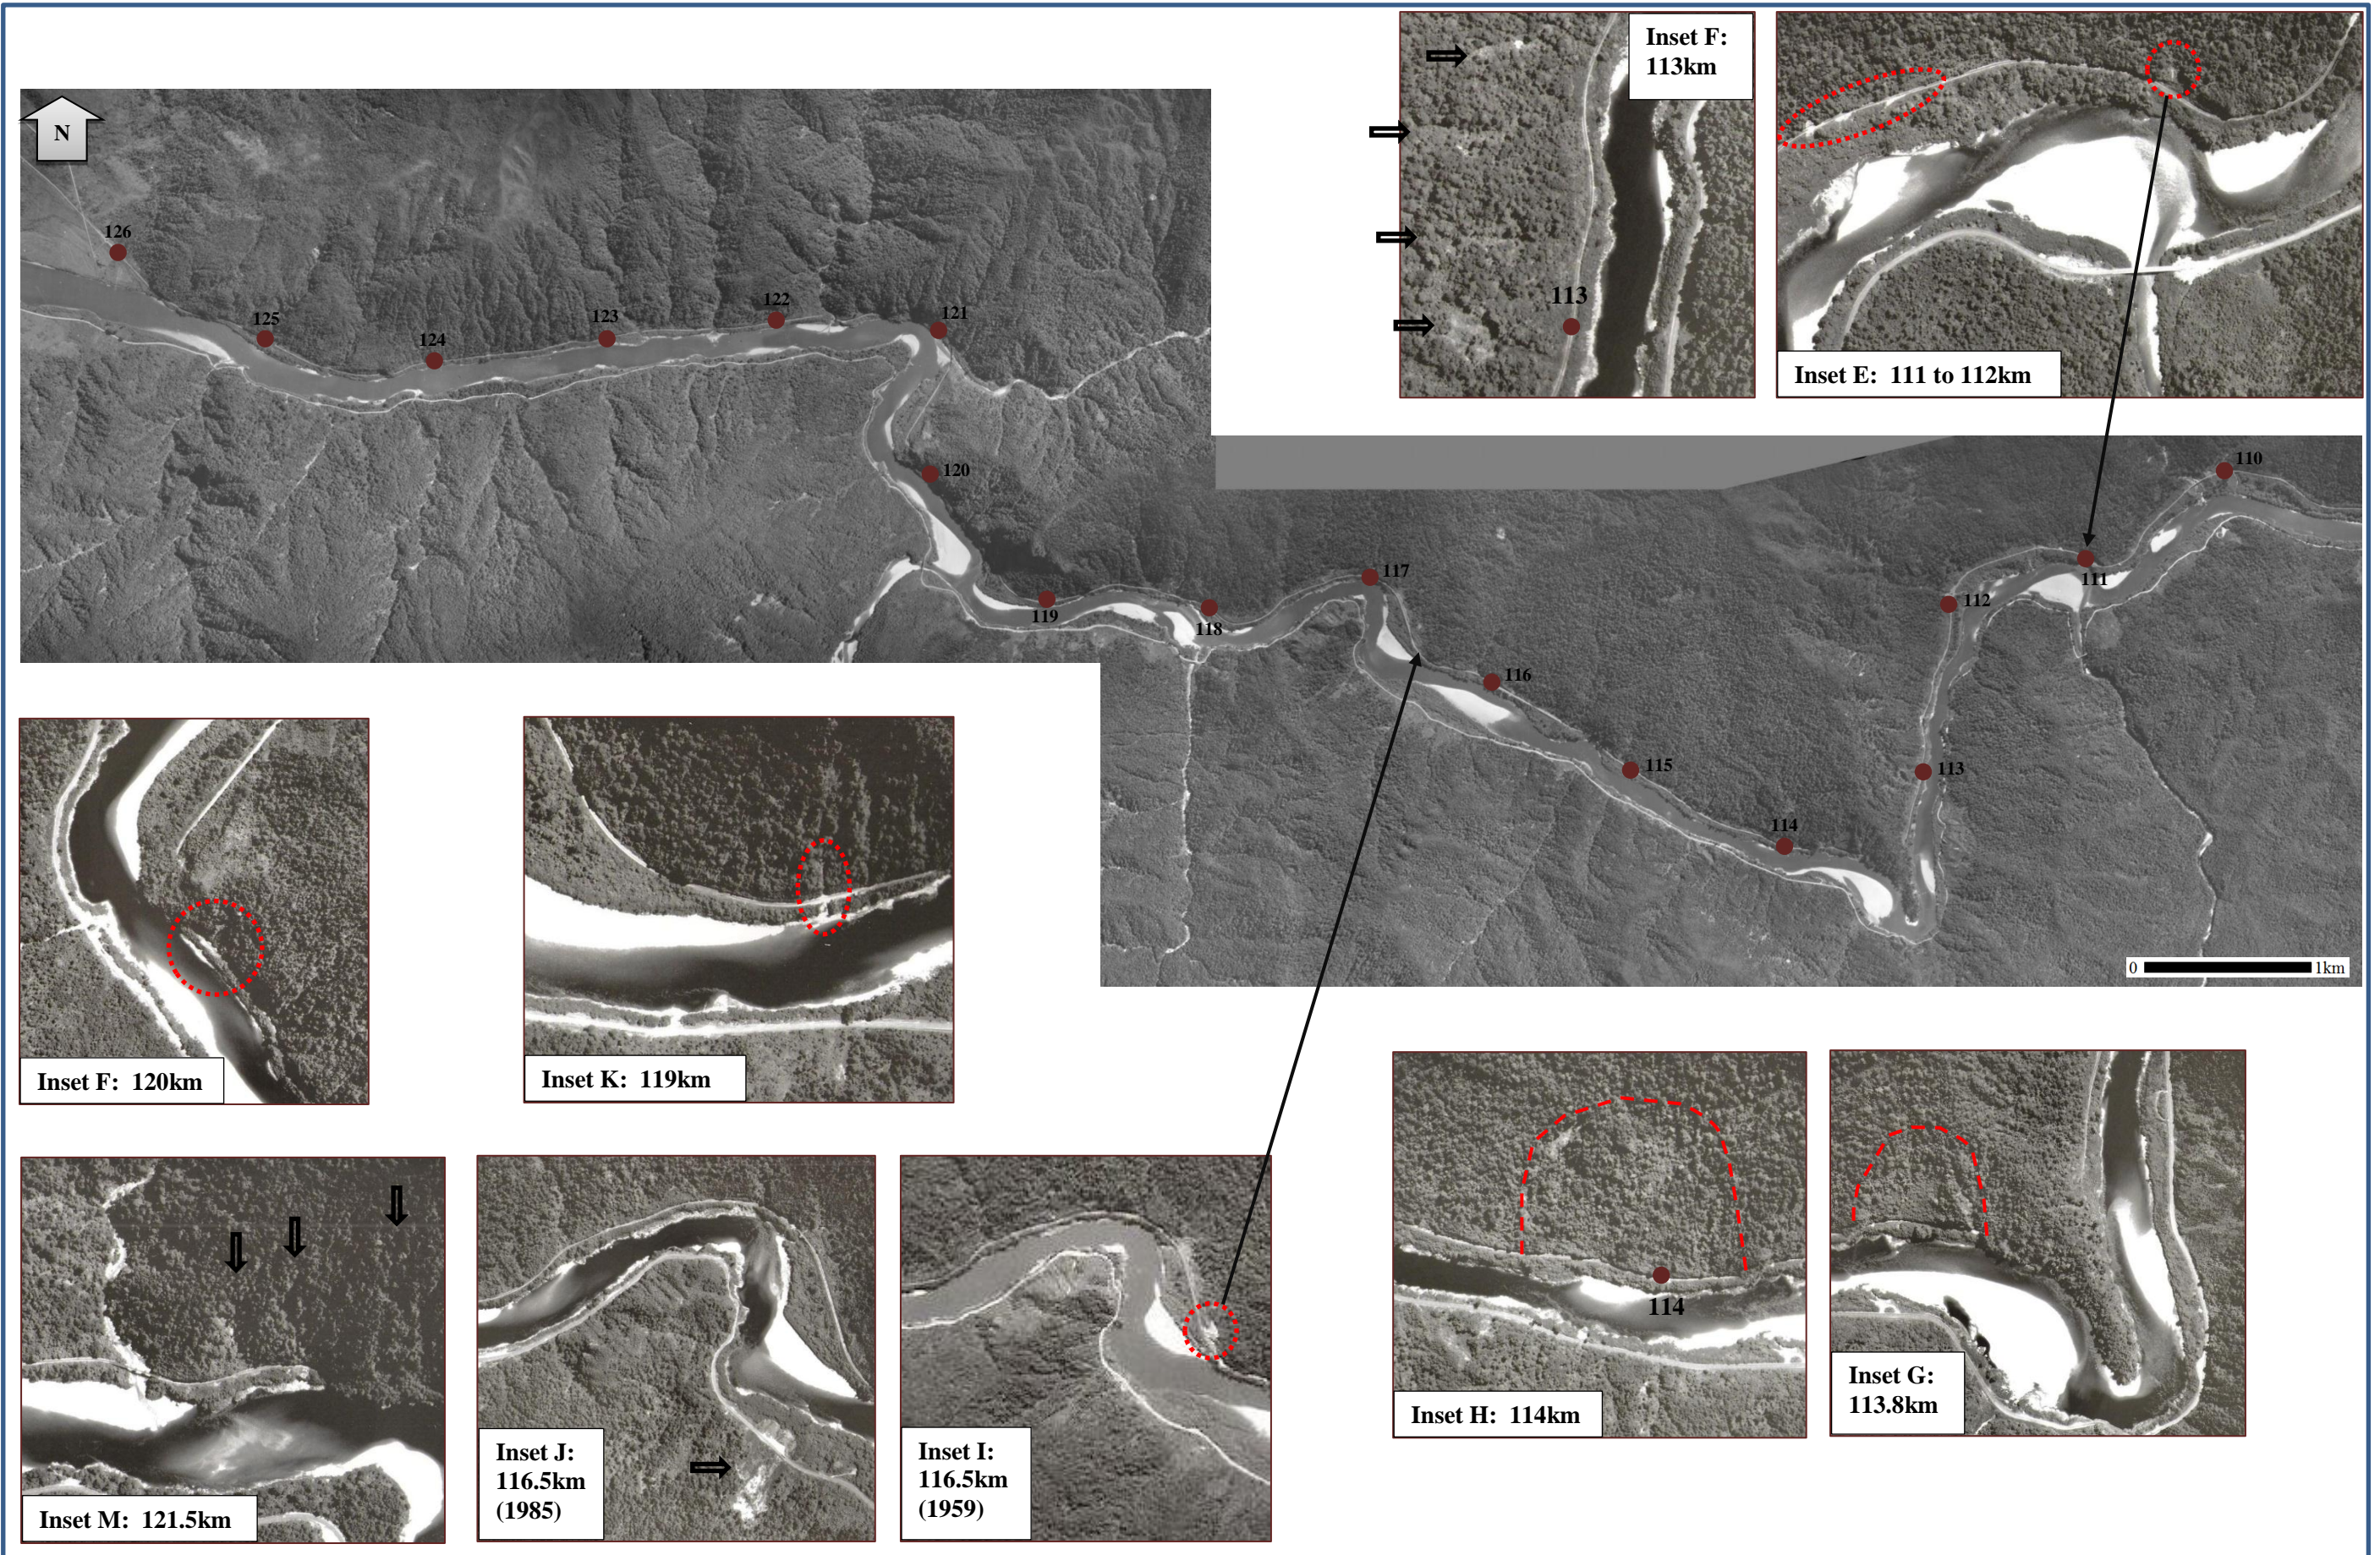
Figure A3.2.2: 1947 aerial photography between SNL110km and 126km. Refer Table A3.2.2 for inset descriptions.

120.0	Recent material disturbance adjacent to rail, possibly related to a landslide above the rail alignment.	Inset L, 1985 (Figure A3.2.2)
121.5	Slope movement near Cascade Creek on the western side of Tunnel 5 evident in 1985. No fresh scars visible in 1947 or 1959 photography.	Inset M, 1985 (Figure A3.2.2)

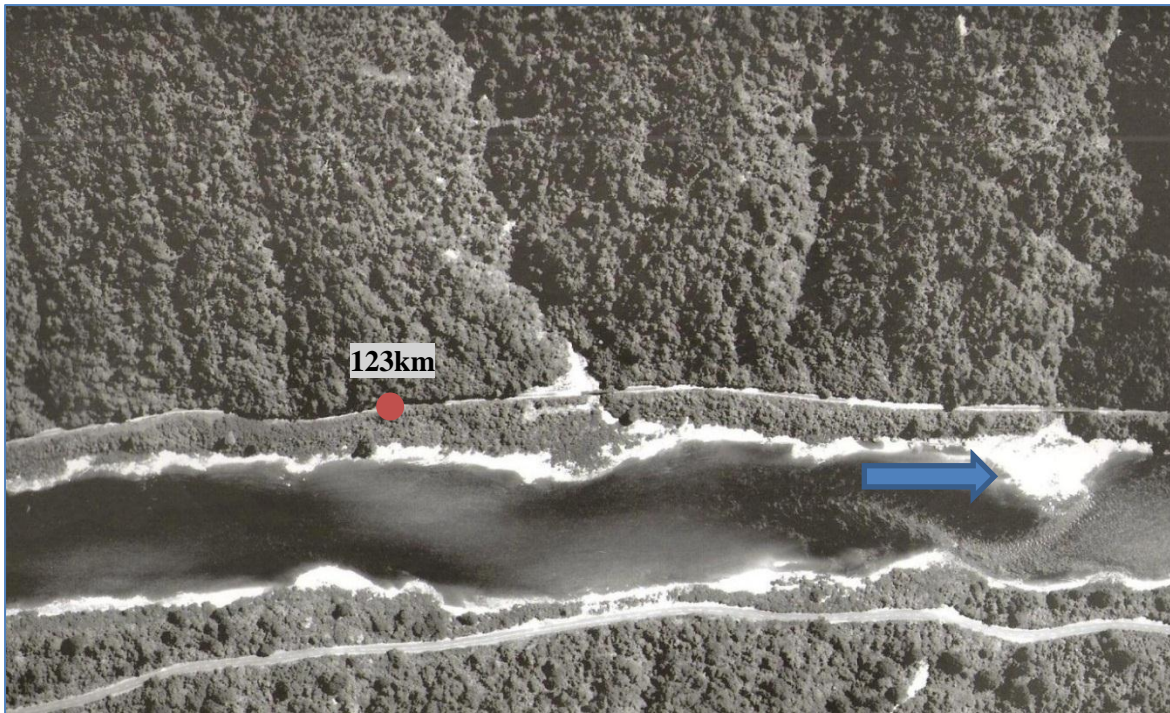
From around 122km to the western extent of the project area at 126km there are numerous steep gullies and streams that intersect the rail corridor. At 122.4km in 1985 the discharge from one of these streams is evident (refer arrow on Figure A3.2.3). Recent landslides are evident in 1985 that have impacted SH6 (opposite SNL125.5km, Figure A3.2.4), and a fresh scar west of the Tunnel 6 entrance.

**Figure A3.2.3: Steep gullies adjacent to the rail corridor and stream discharges creating small alluvial fans in the Buller River. Example shown from 1985 (indicated by arrow).**

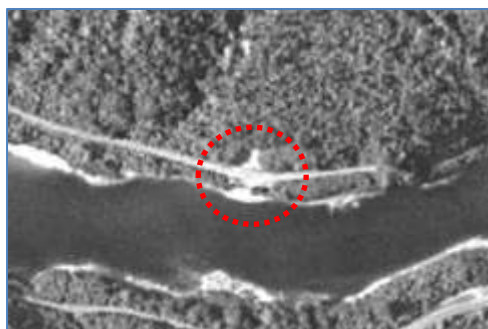
Aerial images available from MapToaster Topo New Zealand were flown in 2000/2001, and cover the Lower Buller Gorge from near SNL111km to 126km only. Image quality is average, as seen in Figure A3.2.6, which shows the only recent slope movement feature immediately adjacent to the rail alignment at the same location as in Google Earth (2003) at ~SNL124.40km. This feature is not visible in 1985 (refer Figure A3.2.4).

**Figure A3.2.6: Slope movement in 2000/2001 near SNL124.40km. Tunnel 6 is visible on right-hand side of aerial photograph.**

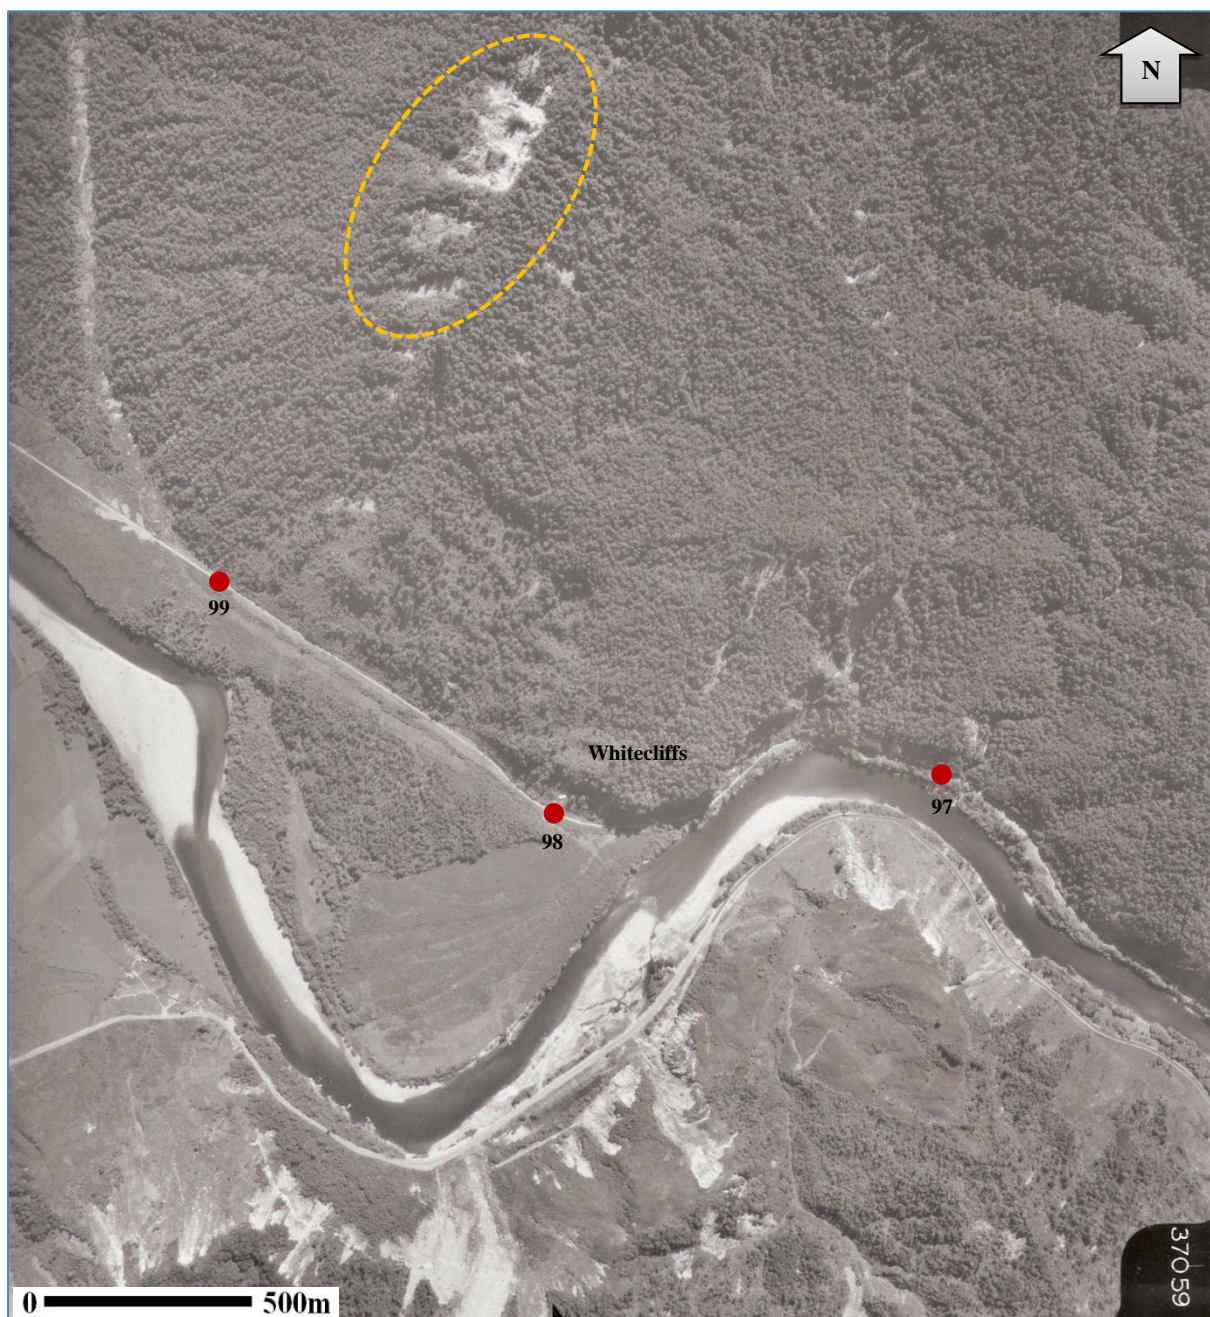
**Figure A3.4.3: 1970 aerial photograph in the vicinity of Whitecliffs and SNL97km to 99km.**

The detached block at SNL98km shown on Figure A3.1.1 from 1985 (Inset B) is also visible in the 1970 photograph (directly above the SNL98km location on Figure A3.4.3). No other slope movement features are visible adjacent to the rail corridor at Whitecliffs. In comparison, widespread landslides and rockfalls are clearly visible on the southern side of the Buller River, adjacent to SH6 and the slopes above. The circled area on Figure A3.4.3 highlights recent slope movement associated with the western side of the hillslope north of SNL98km.

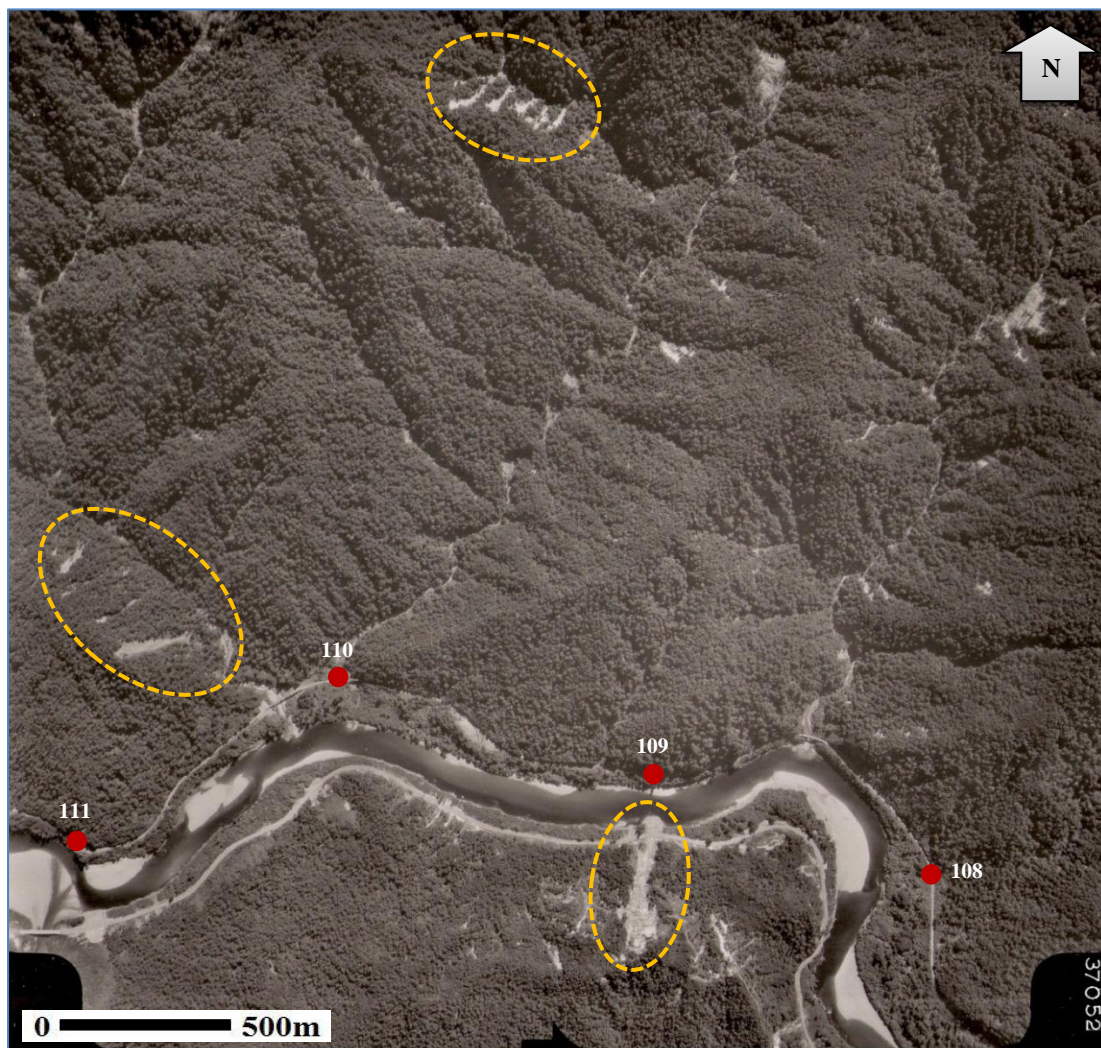
**Figure A3.4.4: 1970 aerial photograph in the vicinity of SNL108km to 111km.**

A large landslide is visible on Figure A3.4.4 that crossed SH6 (southernmost circled location). There are no large-scale slope movement features visible that directly intersect the rail corridor in this area but landslides are visible to the north. Circled locations north of the Buller River show landslides associated with the north to northeastern sides of the two highlighted hillslopes. Comparatively smaller fresh scars in the landscape, than those highlighted on Figure A3.4.4, are also present on both sides of the Buller River but particularly associated with SH6.

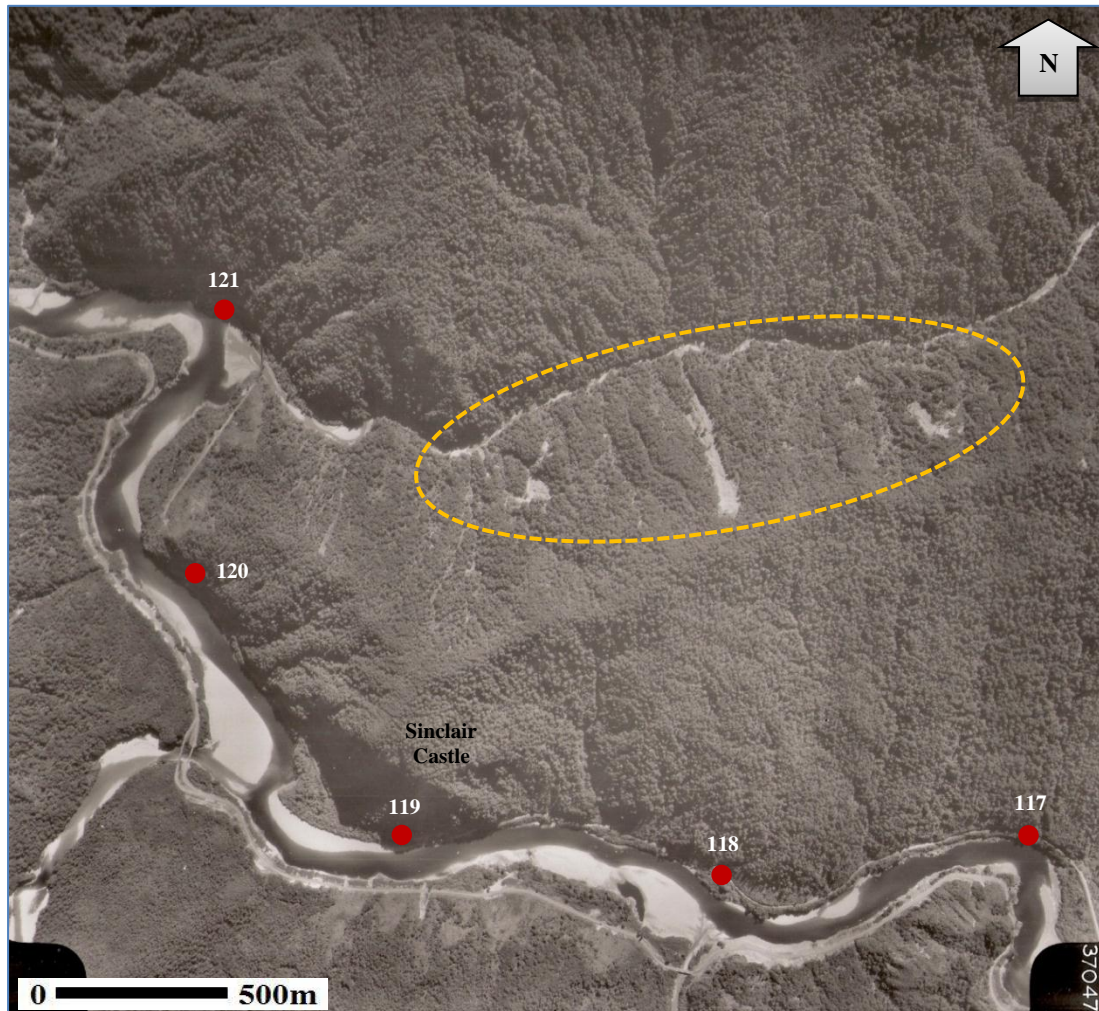
Sinclair Castle is shown on Figure A3.4.5. There are no visible slope movement features associated with the steep topography at Sinclair Castle but the shadow in this area may obscure comparatively smaller scale failures. There are also no direct impacts from landslides visible between SNL117km and 121km. The highlighted area shows fresh scars in the landscape associated with the northern facing slope north of Sinclair Castle.

**Figure A3.4.5: 1970 aerial photograph in the vicinity of Sinclair Castle and SNL117km to 121km.**

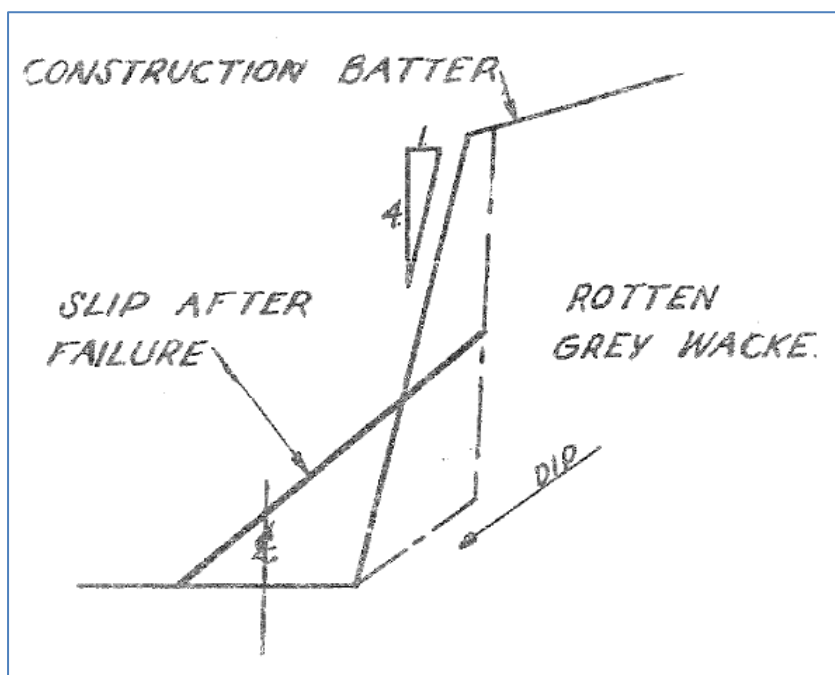
**B. Mudstone (67m40ch or 108.630km):**

At 67m40ch (108.630km) Duckworth (1968) observed rock slides that were predominantly comprised of mudstone, and described as ‘large shattered rock’. Batters at this locality were near-vertical, as indicated by Figure A3.4.6 from Duckworth (1968). There is a discrepancy between the labelling of Figure A3.4.6 as ‘greywacke’ and the text description of ‘mudstone’. The geological unit at this location is mapped by Bowen (1964) as Greenland Group (Figure 2.3, Chapter 2).

**Figure A3.4.6: Sketch diagram from Duckworth (1968) showing a landslide at SNL108.630km**

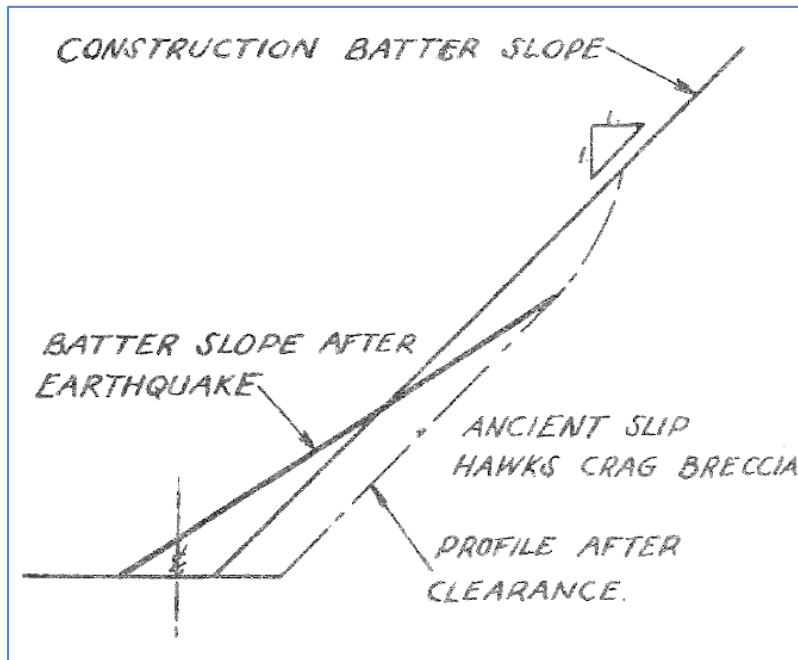
**C. Hawks Crag Breccia (73m peg or 117.482km):**

Landslide material at this location consisted of massive, hard conglomerate (granite and greywacke within a sand/silt matrix) with boulder sizes up to 50 tonnes. The landslide occurred in an area that had failed historically, and was reactivated by the Inangahua earthquake. Batter slopes were indicated by Duckworth (1968) at approximately 1:1 (Figure A3.4.7).

**Figure A3.4.7: Sketch diagram from Duckworth (1968) detailing a landslide at SNL117.482km.**

Remedial works at this location encountered major issues when removal of the rock slide toe support triggered additional slope movement, exposing a progressively wider and higher failure surface. A ‘crib log’ retaining structure was constructed to stabilise the slope in this area. This event correlates to the references made by Fitzpatrick (2007) around the same location (refer Table A3.4.1).

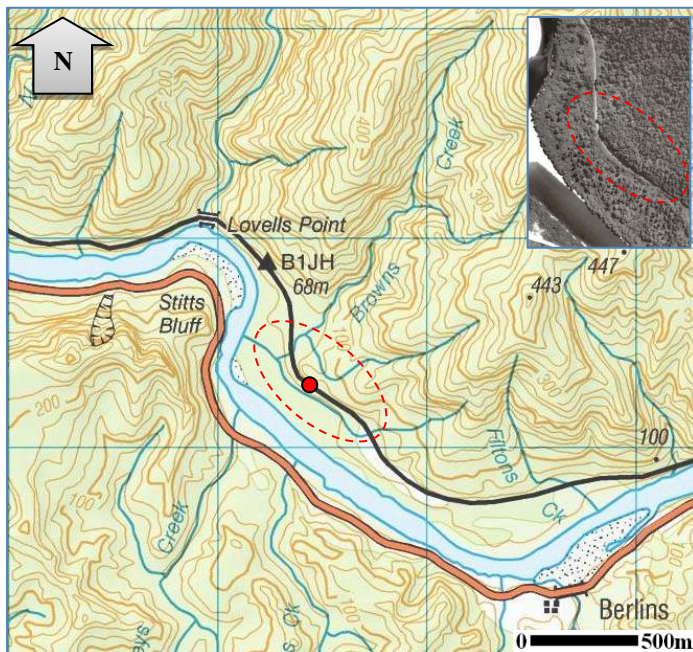
Landslides have resulted in impacts to rail operations in the vicinity of SNL107.50km. A derailment occurred in 2004 within the circled red area on Figure A5.1. No information was made available regarding details of the landslide. The geological map shown in Chapter 4, Figure 4.3, indicates that bedrock in the vicinity of SNL107.50km comprises Hawks Crag Breccia, with Greenland Group outcrops to the north (based on the mapping of Nathan et al, 2002). As seen in Figures A5.2 to A5.3, the unit at this location is actually Kaiata Formation mudstone and sandstone. This is indicative of the limitations of the geological mapping available and the comparatively detailed nature of the rail corridor that is being evaluated in this thesis. The nearest mapped Kaiata Formation exposure is approximately 2km from SNL107.50 (Chapter 4, Figure 4.3).

**Figure A5.1: Location and topography in vicinity of SNL107.50km (half metrage mark indicated by red circle). Inset shows an aerial view from 1985.**

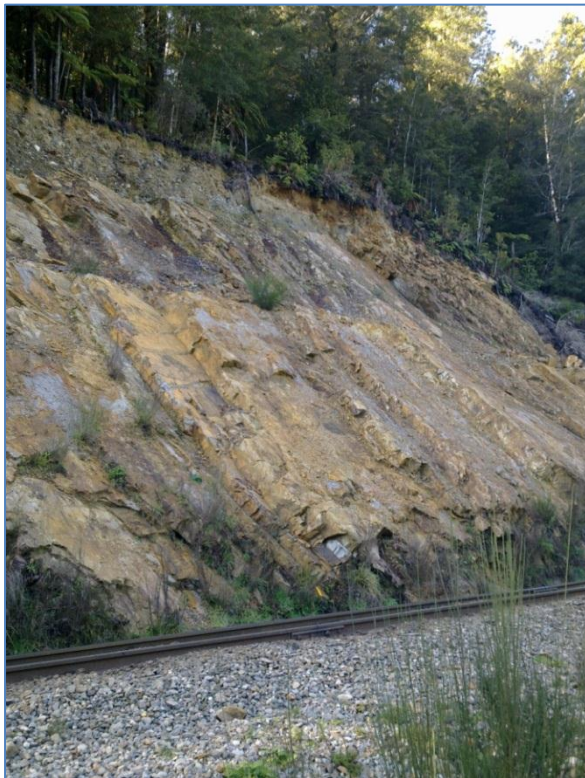
**Figure A5.2: View of rock outcrop near SNL107.50km. Bench tapers out on the eastern (right-hand) side of photograph.**

Remedial works after the 2004 landslide comprised benching the slope and removal of loose rock along an approximate length of 150m adjacent to the rail, as seen in Figures A5.2, A5.4 and A5.5. The photograph of the coal train in Figure A5.5 shows the close proximity of the cut slope to the railway. The bench surface is near level, and loose rock observed in the catch area at the base of the slope indicates the rock trajectory is at times sufficient to impact the rail corridor. The distance between the edge of rail and base of the cut slope averages less than 2m, and the surrounding area is heavily vegetated. It is possible that the presence of Kaiata Formation may not have been recognised until the 2004 slope failure that impacted the rail operations.

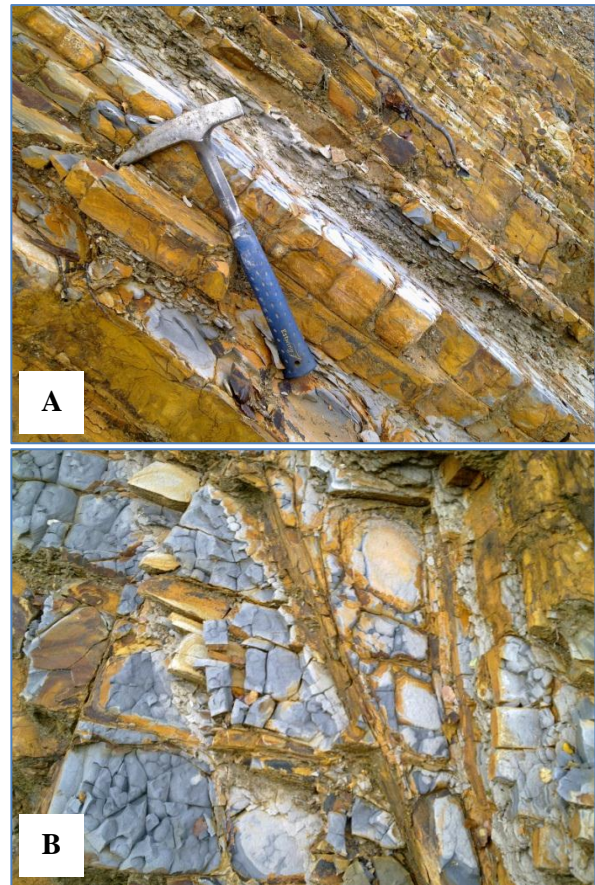
**Figure A5.3: Close-up view of Kaiata Formation interbedded sandstone (A) and mudstone and minor shear zone in batter (B).**

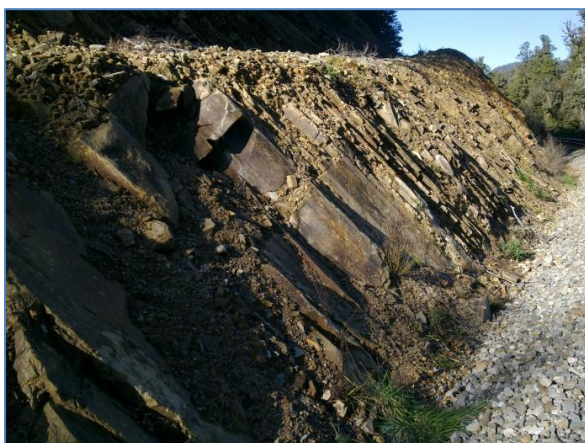
**Figure A5.4: Base of slope (view looking south-east) with bedding daylighting out of slope, dipping around 40-45°.**

Figures A5.2 to A5.5 show bedding dipping around  $45^\circ$  and striking sub-parallel to the railway ( $295 \pm 10^\circ$  True) for a distance of approximately 100m. Measured strikes varied between  $184$  and  $305^\circ$ , and dips between  $39$  and  $53^\circ$  to the south, as depicted by the close concentration of 29 poles to bedding in Figure A5.6.

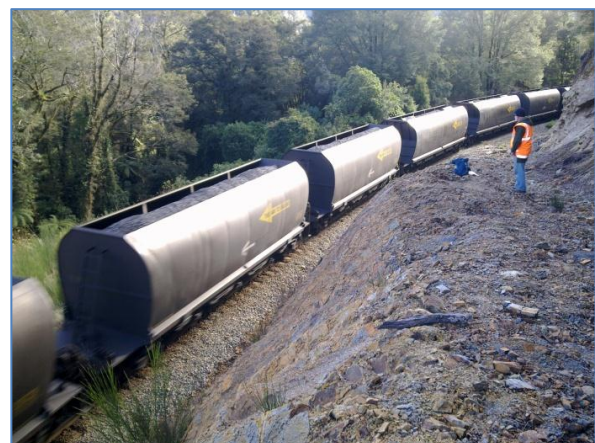
**Figure A5.5: Scale of batter and proximity to coal train movements. Note the limited visibility around the track curve.**

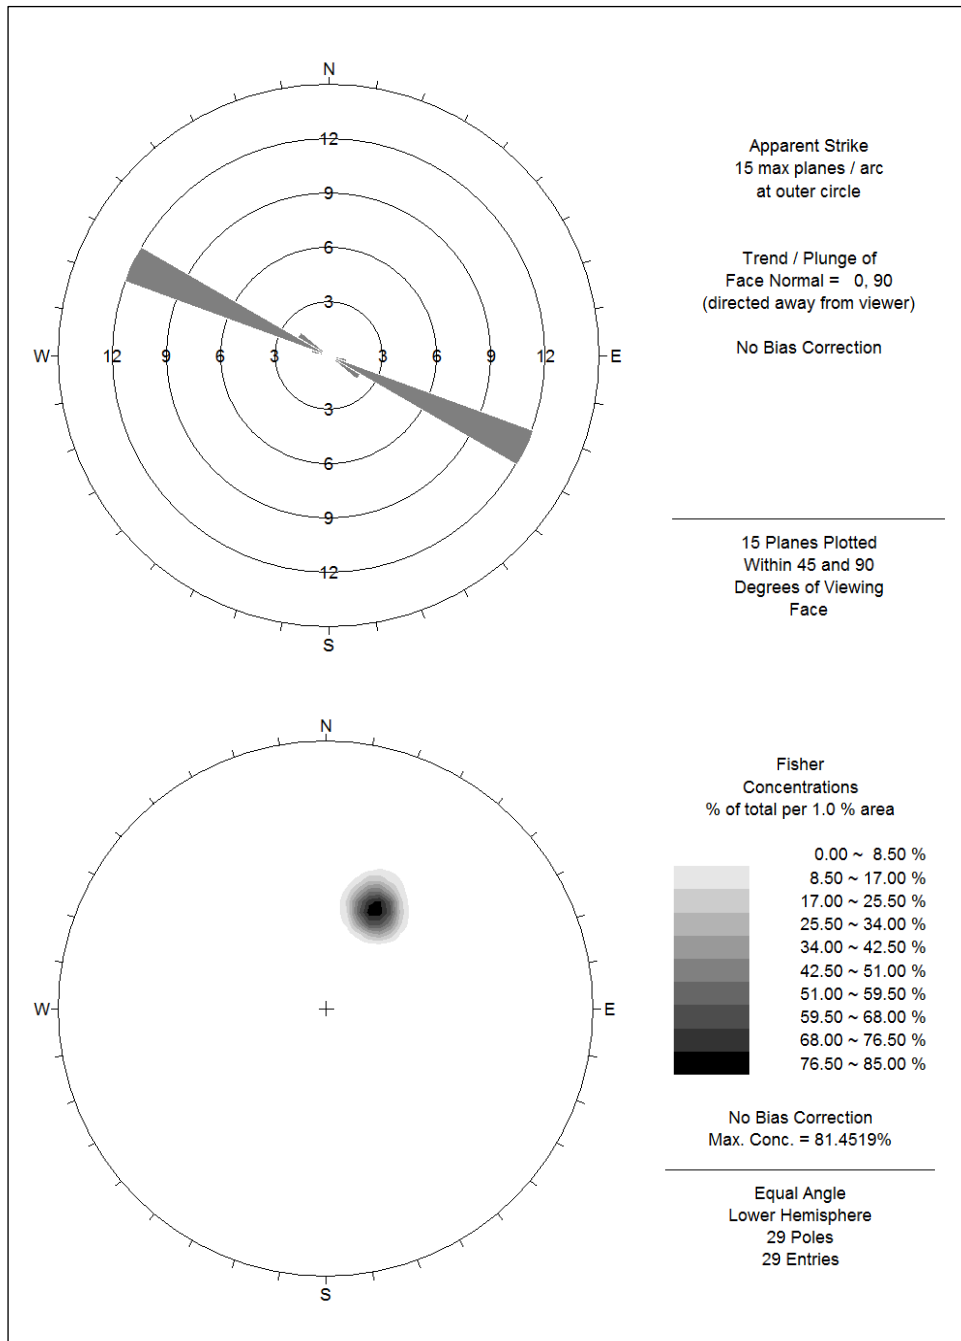
**Figure A5.6: Bedding orientation measured in Kaiata Formation at SNL107.50km**

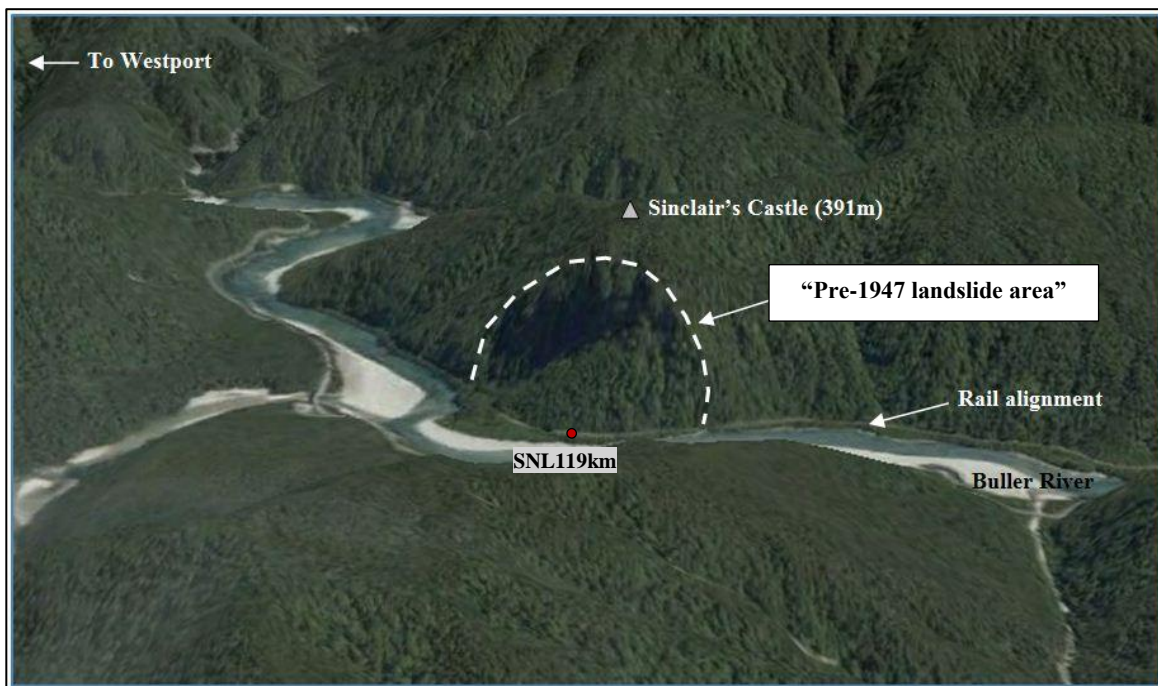
Sinclair Castle is repeatedly referred to within this thesis and in discussions with any person having background knowledge of the project area. The location and elevation of Sinclair Castle is shown on Figure A5.7, including the geomorphic expression of what is interpreted as a pre-historic, re-vegetated landslide that impacted the course of the Buller River. The rail has been formed through the toe of the pre-1947 landslide, this being the earliest dated aerial photography available on which the much older landslide is evident. Gully-controlled smaller slope instability features on the older, and seemingly stable, landslide are of concern to railway operations. These are evident through the trees within the “Pre-1947 Landslide Area”, as shown in Figure A5.7, and they episodically reactivate during intense rainstorms to release rock debris towards or onto the rail corridor.

**Figure A5.7: View of Sinclair Castle (from Google Earth, image dated 1 April 2003)**

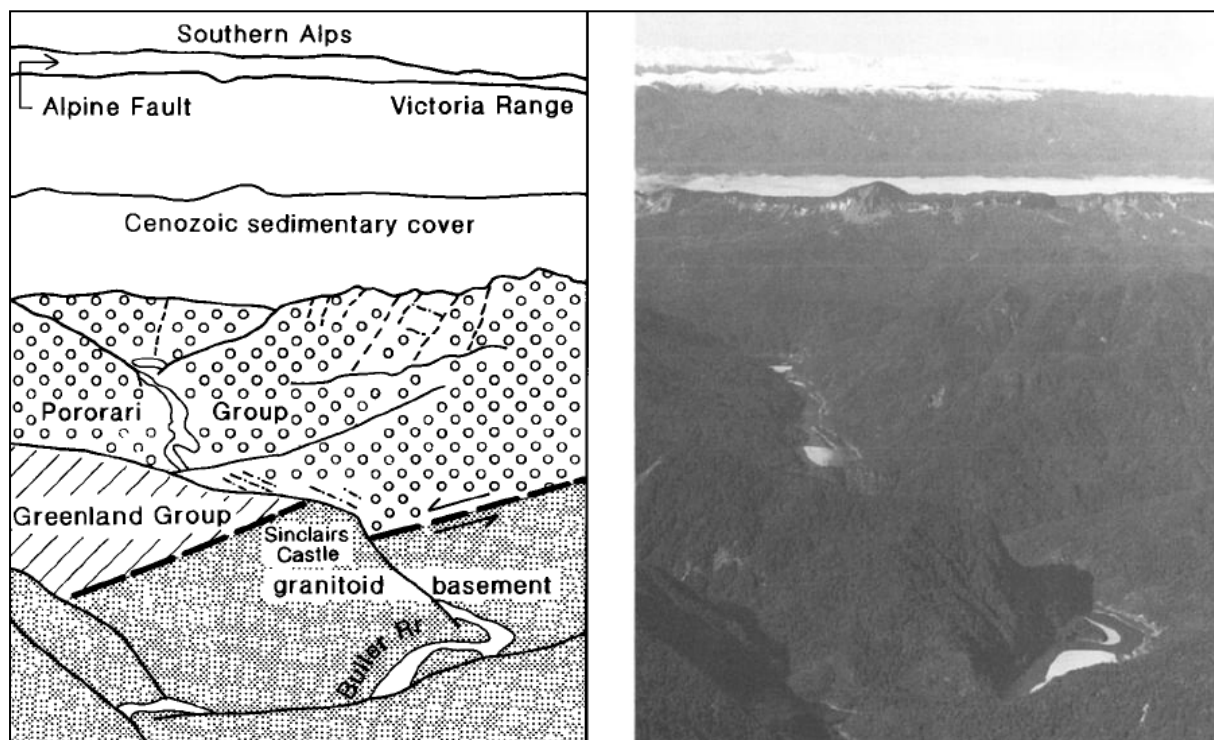
Figure A5.8 shows the interpretation made by Tulloch and Kimbrough (1989) of the southwest tilting Pororari Group beds (dot/dashed lines) into the detached segment (heavy-dashed lines). High-angle normal faults within the Pororari Group are represented in Figure A5.8 by the comparatively lighter dashed lines. The oblique aerial view looking upstream shows the position of Sinclair Castle as a prominent outcrop of “granitoid basement” (terminology from Tulloch and Kimbrough, 1989), and the steep southeast-facing slopes forming the rear of the “Pre-1947 Landslide Area” are evident on the upstream side of Sinclair Castle in Figure A5.7.

**Figure A5.8: Aerial view from Tulloch and Kimbrough (1989) of Sinclair Castle looking towards the east up the Lower Buller Gorge. Refer text for description.**

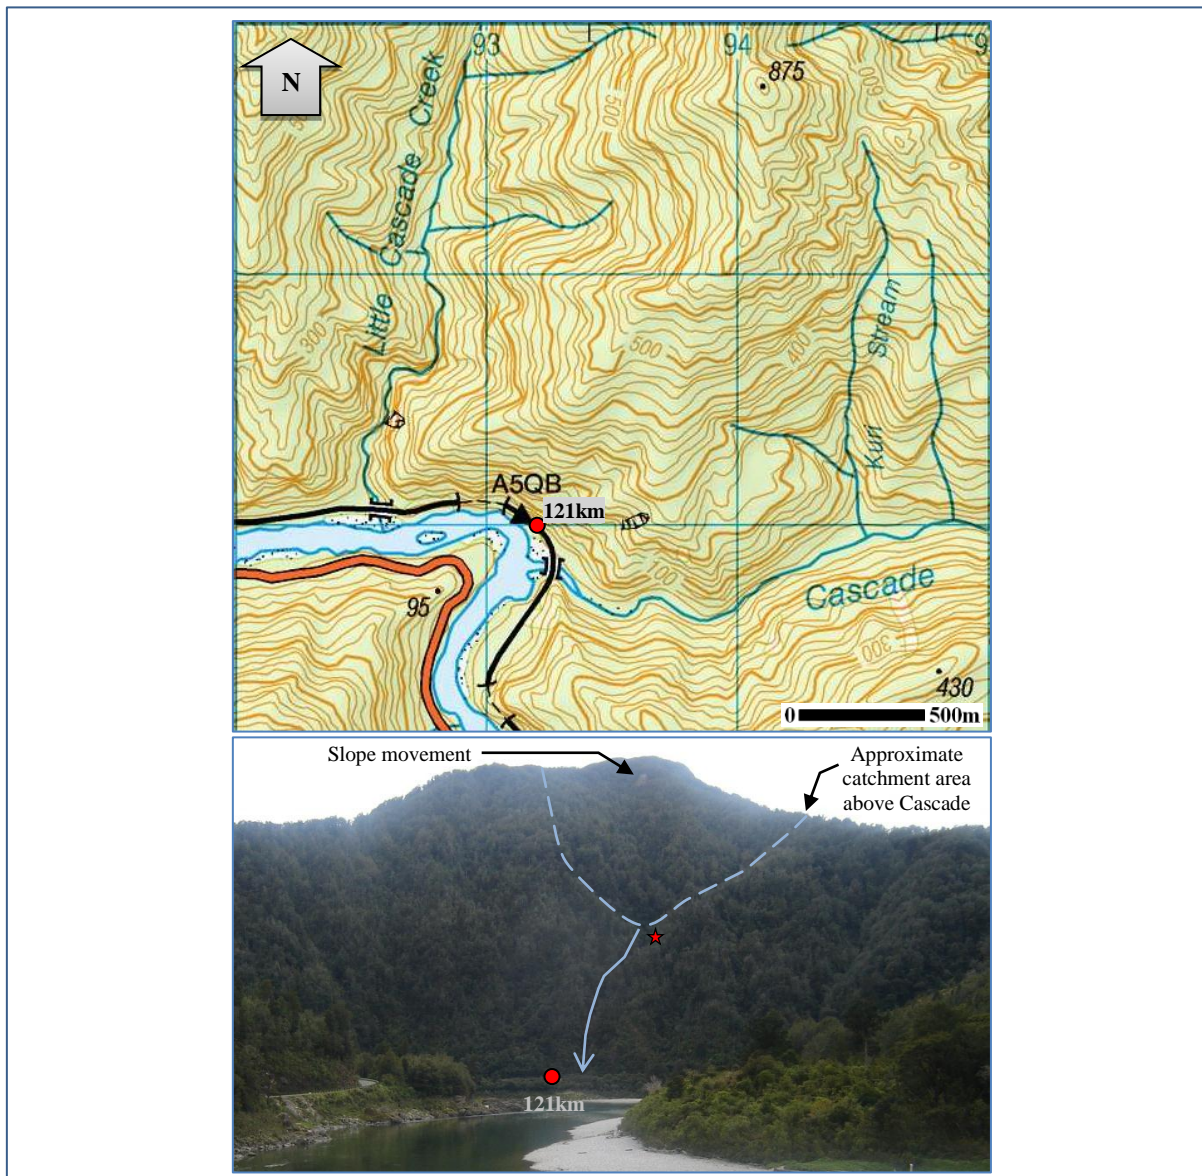
**Figure A5.10: Topographic contours in the vicinity of Cascade (top) and photograph taken from SH6 looking towards the catchment influencing slope stability at Cascade (bottom). Star indicates approximate location of the diversion tunnel.**

Figure A5.10 shows the steep nature of the bush-covered slopes above SNL121.0km, and the extent of the catchment that feeds the partly incised gully system on the lower slope. The size of the granite blocks that have been transported through the system is evident in Figures A5.11 and A5.12, and boulders exceeding 1m<sup>3</sup> were present upstream of the tunnel portal site. Areas of slope movement in the upper catchments are visible in Figure A5.10 (arrowed), and localised shallow failures in near-surface weathered granite were evident in the vicinity of the diversion tunnel itself. This is part of the normal weathering cycle in granite bedrock on steep slopes with high annual rainfall, and episodic extreme storm events involving regolith saturation and translational sliding at the bedrock interface.
